Flooding at Quorn?

Semi-retired Water Engineer

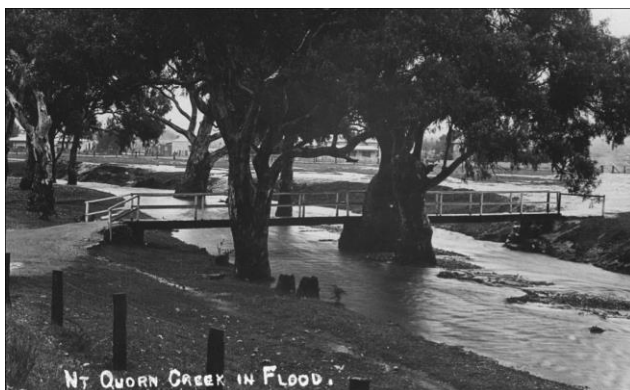
The LH photo shows a small flow in Pinkerton Creek at a location in the town. The sheets of water on the far bank highlight the very low banks and ease of overflow onto the adjacent flat land. The trees in the bed and the sediment/gravel shoals downstream of the trees indicate an unstable bed with the likelihood of trees falling and blocking the flow in larger floods and adding to the overflow problems.

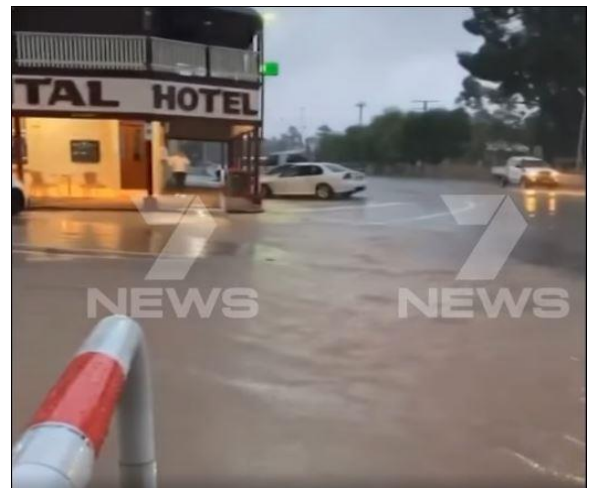
The RH photo was taken in Oct 2020 looking west up the main central street with the Creek located over to the RHS behind the trees. It would appear that the Creek has overflowed its banks and the flow is escaping down through the town centre towards Capowie Creek. A Google Earth survey (only accurate to about +/- 1m) shows the creek at 300m, the road level in the photo at about 299 m, the level at the southern end at 298 m and Capowie Ck at 292 m.
